## Natural risks and monitoring systems: Case study of the mining-industrial heritage objects of Karelia (Ruskeala Mining Park), Russia

Shekov, V. A. 2021. Natural risks and monitoring systems: Case study of the mining-industrial heritage objects of Karelia (Ruskeala Mining Park), Russia. *Vestnik of MSTU*, 24(2), pp. 214–227. DOI: <https://doi.org/10.21443/1560-9278-2021-24-2-214-227>.

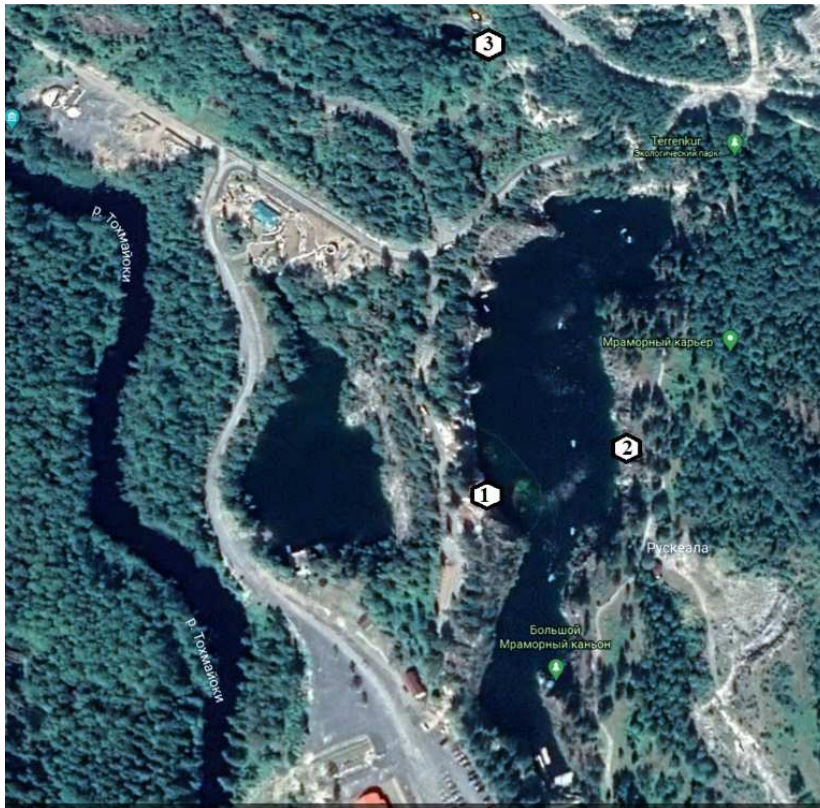
The surveyed territories are recorded in photographs and presented in the form of polygonal models. The western side of the quarry (indicated by number 1 in Fig. 4) is a vertical cliff up to 30 meters high, part of which is hidden under water. Considering the instability of this kind of walls and its collapse prism, traces of previous collapse, it can be assumed that it is in a state where its collapse can occur at any time. Therefore, photographs were taken along the western side for further processing of materials by photogrammetry methods – to obtain models of the wall.

The east side is in a safe condition: the angle of inclination is 45–60 degrees and does not exceed the critical value. This ensures a steady and stable condition for most of the quarry east wall, where the risks of injury are eliminated by erecting fencing.

Fig. 4. Geography of Ruskeala Park (*Google Earth Photo*). North at the top;  
1 – the west side; 2 – the east side; 3 – underground workings  
Рис. 4. География парка Рускеала (фото Google Earth): север вверху;  
1 – западная сторона, 2 – восточная сторона, 3 – подземные выработки

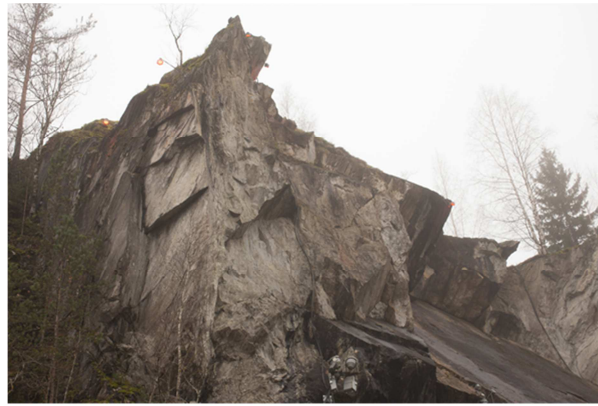
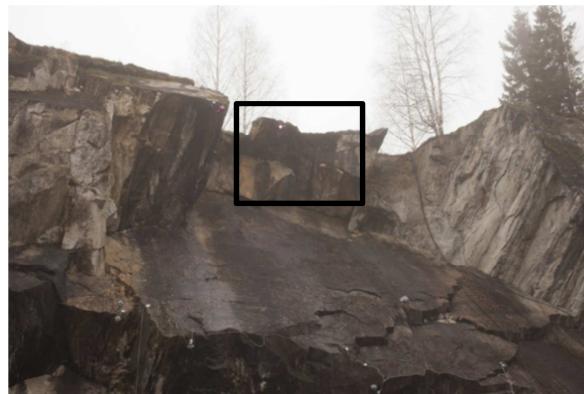
A detailed survey of this site has shown that some of the rocks on board hang over the filled quarry and its stability is controlled by the strength of the rocks, as shown in Fig. 7, *a*, or due to the wall cracks shown in Fig. 7, *b*.

The areas shown in Fig. 7 are characterized by the fact that earlier in this place there were significant downfalls of pieces and blocks of different shapes and volumes. The remained shapeless pieces of varying volumes remain on the board of the quarry and their condition is currently undetermined. Some of them can collapse at any moment when significant loads appear on the upper edge, and some parts can be stable in the absence of loads (Fig. 8). The situation is aggravated by the presence of systemic cracks falling at the angle of 45–50 degrees towards the lake, along which some large pieces of the massif have already fallen earlier.

The area represented in Fig. 7, *b* from the western side is the remnant of the downfallen block (the place is highlighted by a black rectangle), which is sandwiched between two cracks. The right crack at the top deflects slightly giving a wedge shape to the clamped block. In the lower part of the structure, breakaway pieces are visible, jamming the bulk of the stone hanging over them. The structure is in an extremely unstable condition and can collapse at any time if small pieces holding the overhanging block fall out.

The unstable part of stone is dangerous for visitors, especially for those who constantly approach it. From the side of the tourist trail, this part looks safe, and this can deceive visitors.

Fig. 7. Overhanging parts of the rocks are in a threatening condition: *a* – the protruding ledge; *b* – a wedged part of the blocks being in an unstable state, the rectangle shows the locked part of the structure (photo by V. Shekov)

On our recommendation, it was strictly forbidden to approach this slope for visitors. Later, the castle stone was removed and the entire structure hung on it was collapsed managed with the removal of hanging blocks, as shown in Fig. 9. However, the collapsed mass revealed another problem – the crack along which this block is adjacent to the wall. In the block itself, you can see the cracks caused by stretching, which could be opened unpredictably. The hanging block should be dismantled and brought down into the lake as soon as possible.

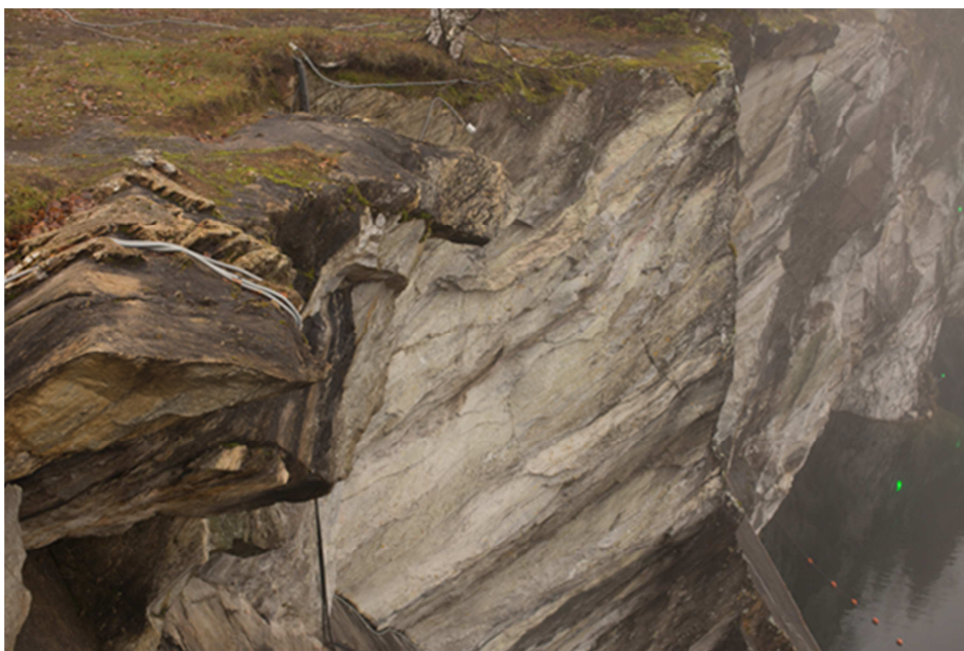
Fig. 8. The overhanging stretch of rock shown in Fig. 7, *b* from a different angle (photo by V. Shekov)

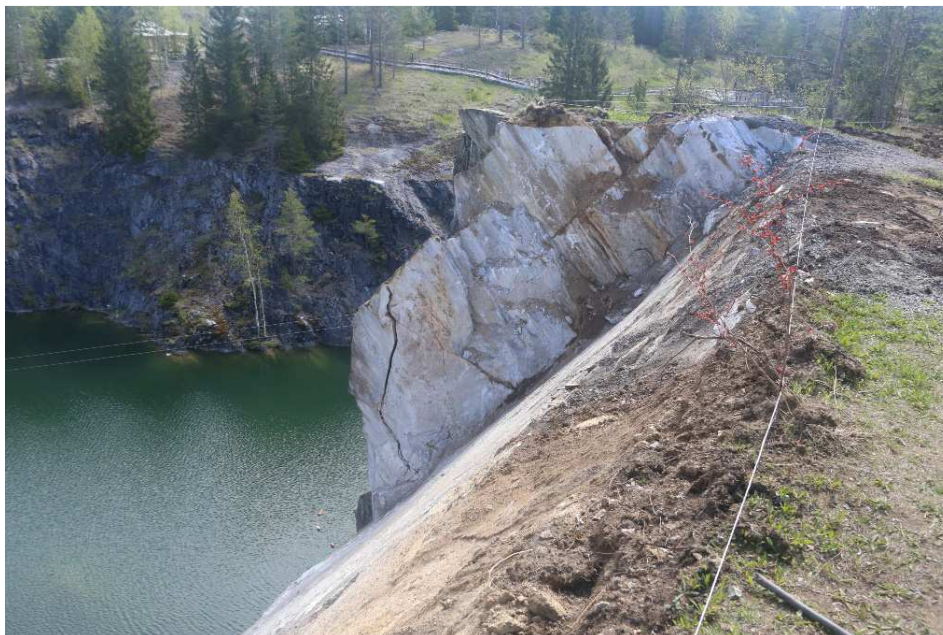
In the left side of Fig. 9, the overhanging "visors" of rock with unspecified stability are clearly visible.

Fig. 9. The result of the collapse of the hanging parts of the site (shown in Fig. 7) (photo by V. Shekov)  
Рис. 9. Результат обрушения свисающей части площадки (рис. 7) (фото В. Шекова)

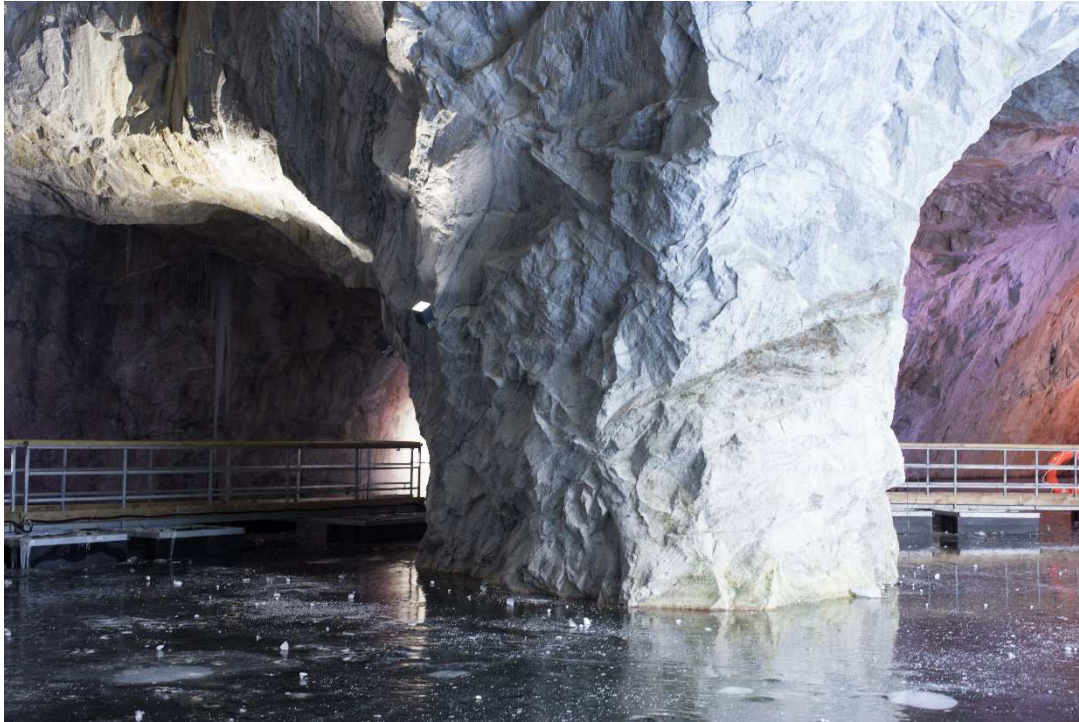
Fig. 11. Fragment of the marble hall with the pillar and the path for tourists, the actual height of the pillars is shown in Fig. 1. The water is frozen (photo by V. Shekov)  
Рис. 11. Фрагмент мраморного зала с колонной и тропой для туристов, фактическая высота столбов показана на рис. 1. Вода полностью замерзла (фото В. Шекова)

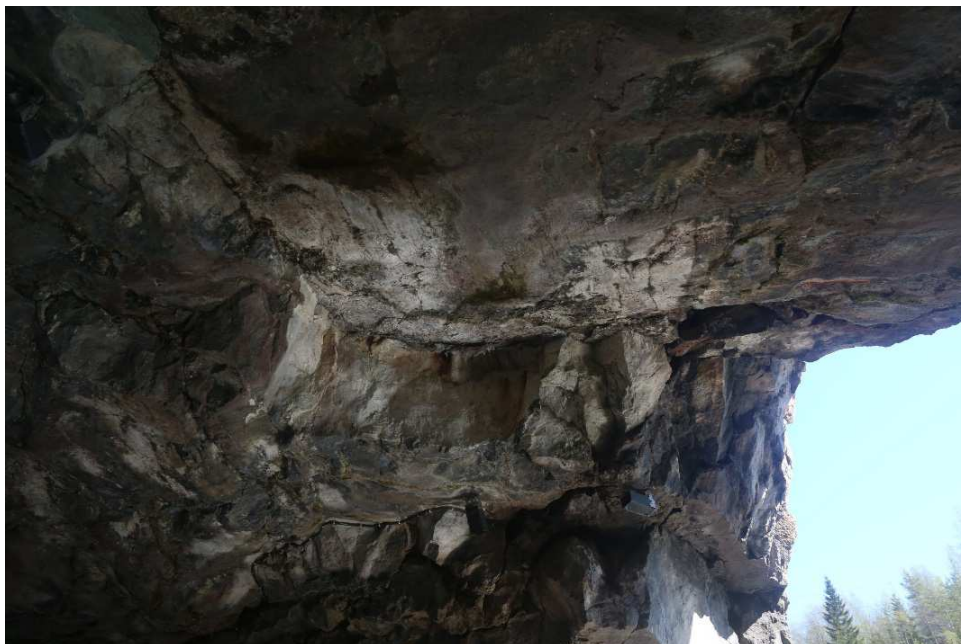
As an example, a visitor can distinguish the area located in the right gallery (Fig. 11) at the exit of the underground route. Here, the arched entrance is broken by various systems of cracks, which lead to the appearance of dangerously overhanging monoliths, weighing 300–400 kg, located directly above the route, as shown in Fig. 12.

Fig. 12. The character of the cracking on the site adjacent to the exit of the gallery (photo by V. Shekov)  
Рис. 12. Характер трещиноватости на участке, примыкающем к выходу из галереи (фото В. Шекова)

The movement of one monolith has been detected by a laser device, the network of which is used in the Ruskeala Mountain Park to monitor the stability of the array and the threat has been eliminated. The operation of laser devices will be described in more details below.

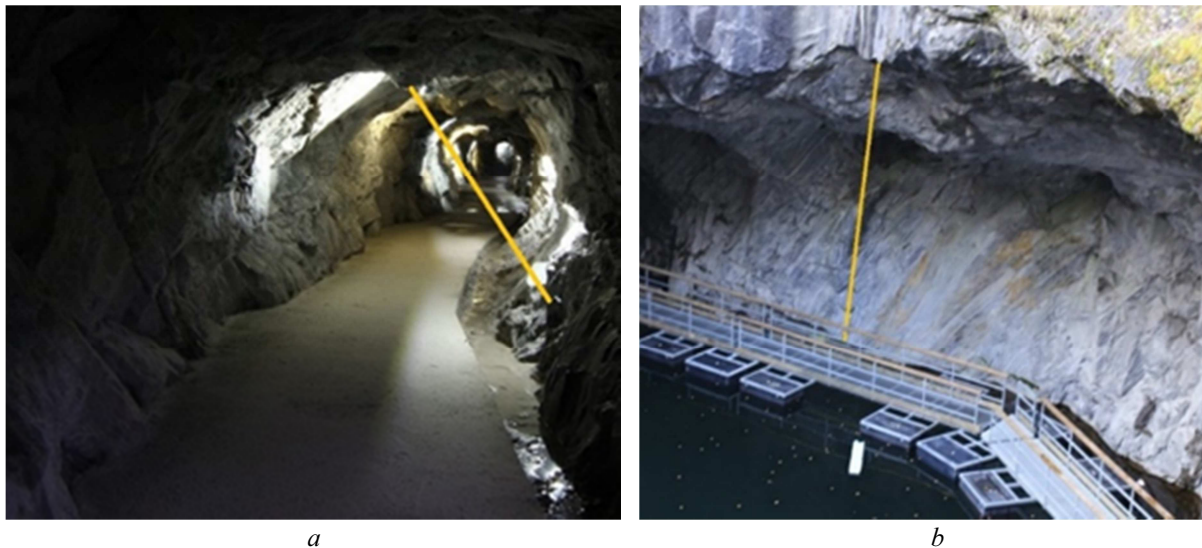
In Fig. 14, *a* – the length of the laser beam is about 2 m, in Fig. 14, *b* – the laser beam length reaches 8 m. The distance to control is determined by the rangefinder range and the accuracy of the measurement. Modern laser rangefinders provide up to 1 mm accuracy in devices that cost less than \$100 and applied for up to 100 meters.

Fig. 14. Examples of measurements in various conditions in underground workings  
Рис. 14. Примеры измерений в различных условиях в подземных выработках

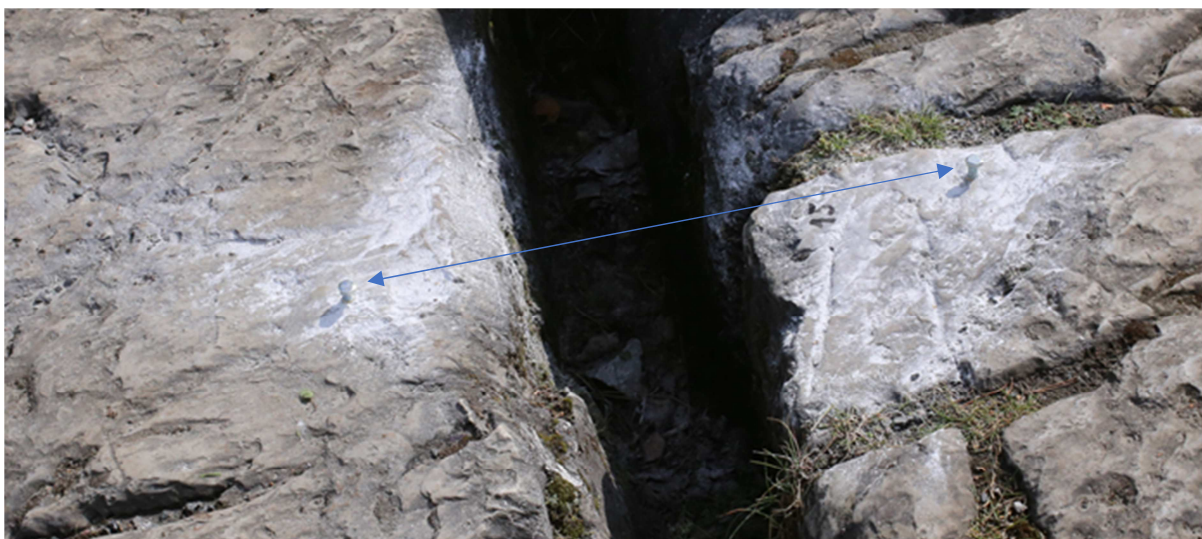
For small distances in open areas, it is possible to use a modified measurement method, here it is uses two metal screws embedded in the rock, as shown in Fig. 15.

Fig. 15. Scheme to install metal screws embedded in the rock for measurements with laser devices  
Рис. 15. Схема установки металлических саморезов (реперов) в скале для измерений лазерными устройствами

To control the cracks, two metal screws are embedded in rock on both sides (two bolts with a hexagonal head are placed in the rock) and two side faces of the head are oriented on both bolts parallel to each other.

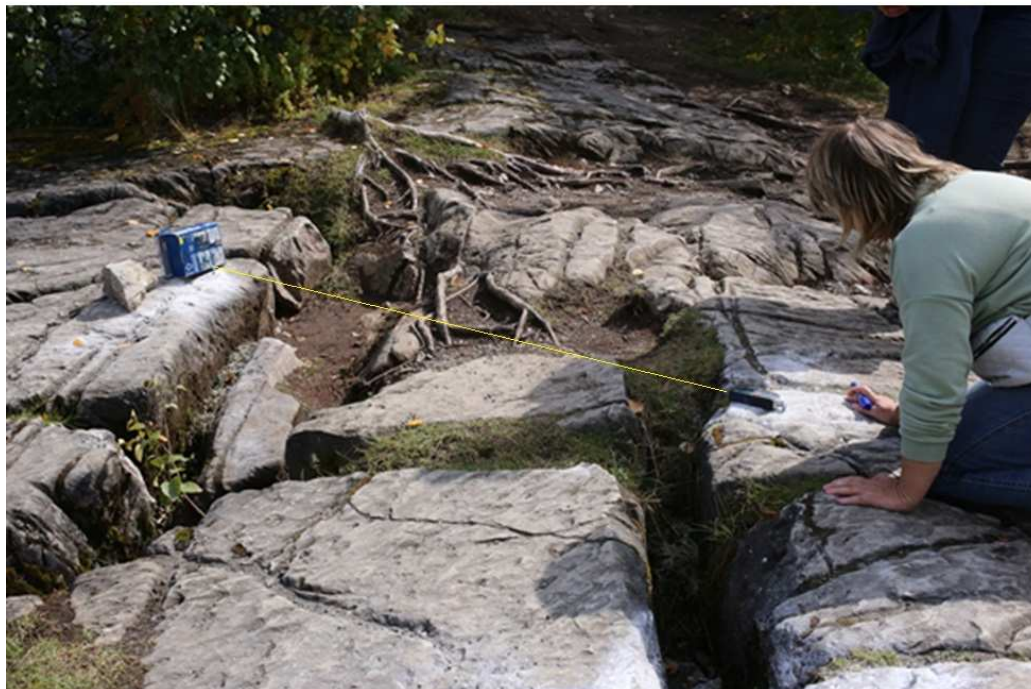
After that, the procedure for taking the distance readings between these metal screws will consist of using any (preferably of high accuracy) laser rangefinder, one end (heel) which will be mounted on the side of the head of one metal screw and will measure the distance to the side face of the head of another metal screw, thus fixing the expansion of the crack or if necessary – the ensembles of cracks, as it is shown in Fig. 16.

Fig. 16. Measuring the distance between two metal screws set to control crack expansion parameters  
Рис. 16. Измерение расстояния между двумя металлическими винтами (реперами), установленными для контроля параметров расширения трещин
